Neck fracture of a cementless forged titanium alloy femoral stem following total hip arthroplasty: a case report and review of the literature

Journal of Medical Case Reports 2007, 1:174 doi:10.1186/1752-1947-1-174

Case presentation: This case report describes a fracture of the neck of a cementless forged titanium alloy stem coated in the proximal third with hydroxy-apatite.

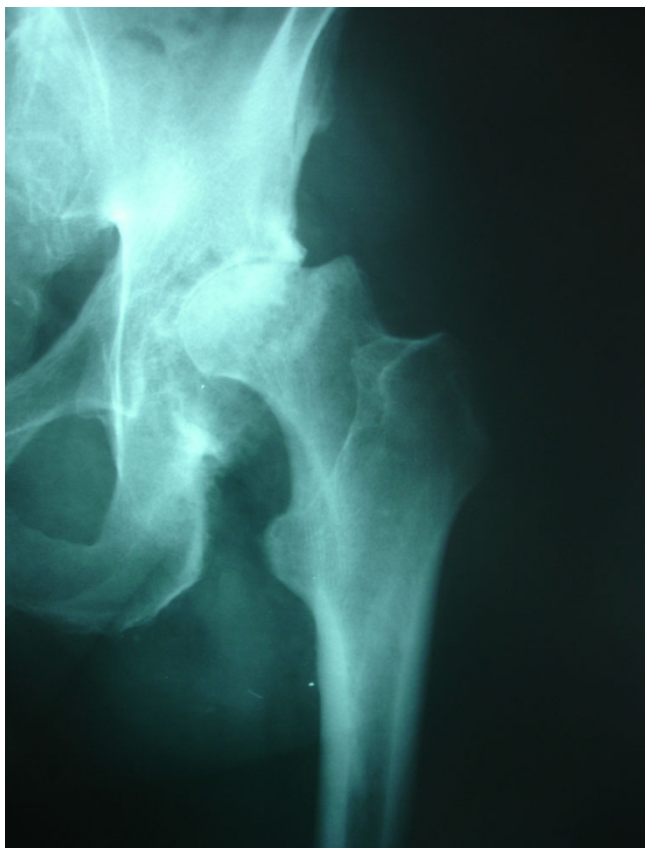
Figure 1
Preoperative anteroposterior radiograph of the left hip.
Avascular necrosis of the left hip.

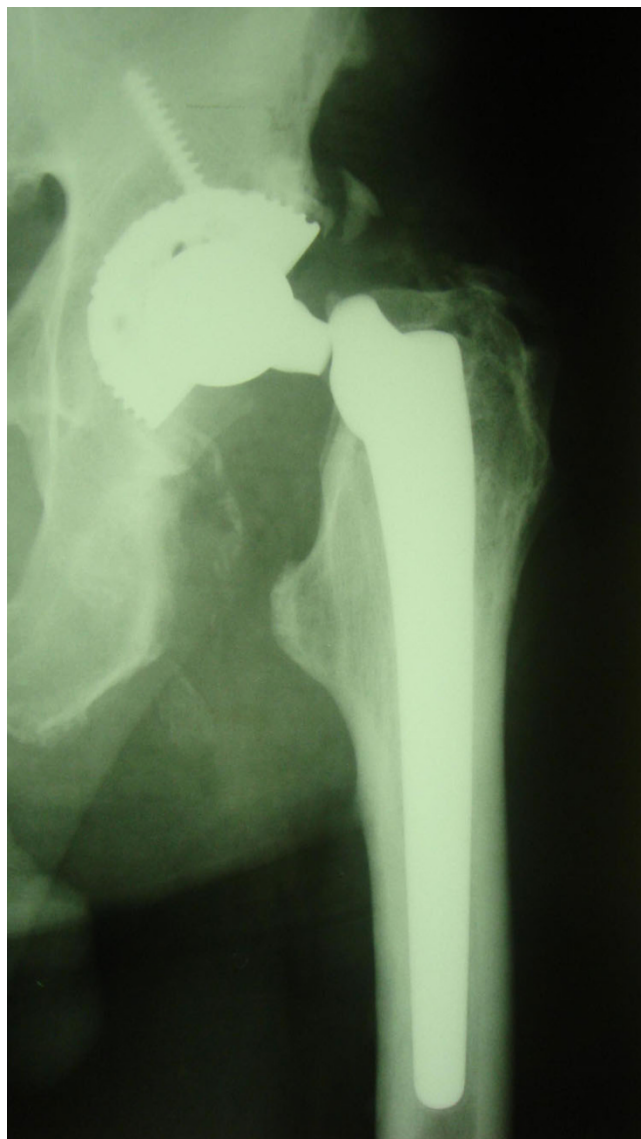
Figure 2
Fractured neck of the femoral implant prior to retrieval.

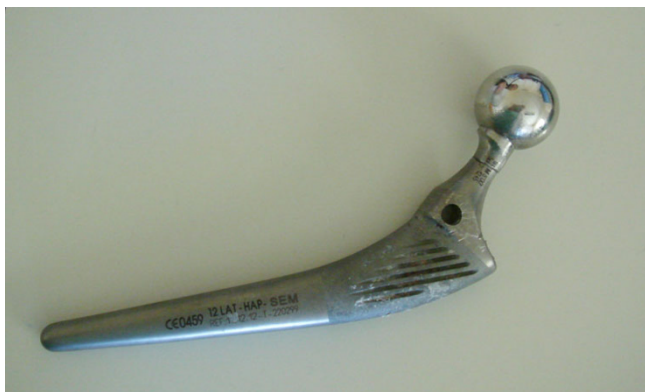
The examination of the stem and neck (figures 3 and 4) shows that this model has a neck machined for a better range of motion and impingement avoidance, with material removed mainly on the medial side, but machining extends also to the posterior and anterior aspects. Apparently, the fracture occurred at the smallest section of the neck, where the diameter is reduced to approximately 9.8 mm, corresponding to a surface area of 75 mm². The laser etched markings lie on the anterior aspect of the stem, when used in a left hip. Additional laser etched markings are made on the neck, giving the indication relative to the characteristics of the cone (SEM 8.00' and SpD2 = 12,45). These markings lie also on the anterior aspect, when the stem is implanted on a left hip. Scanning electron microscope figures of the fracture surface of the part supporting the head clearly show that the fracture has ended on the posterior side. Typical beach marks can be seen in the middle of the surface (arrows on figure 5). This beach marks are characteristic of the beginning of intergranular fracture, after a first stage of fatigue crack propagation. The second stage of the fracture consists in an intergranular fracture, located in the region marked a on figure 5, and shown more clearly in figure 6. The very last stage consists in a shear lip (marked region b in figure 5 and figure 7), oriented to 45° relative to the plane of intergranular fracture, and characteristic of the very end of the fracture due to shear stresses. Except for the intergranular fracture, which is very clear, the other fracture surfaces are smeared and polished from abrasive contact in vivo as enhanced by biological lubrication (see fragment contact in figure 2). Examination of the edges of the surface with a stereomicroscope reveals marks of tools, probably iatrogenically caused during retrieval of the implant. Unfortunately, these marks lie on the anterior aspect just in the vicinity of the laser markings, and interfere with possible other marks of fracture. Scanning electron microscope examination of the edge of the surface near the laser markings cannot show any clear evidence of initiation of

Figure 3
The retrieved stem.

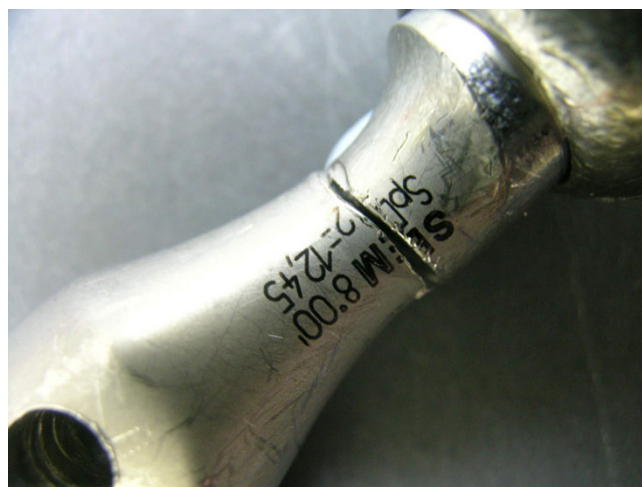
Figure 4
The fractured neck of the femoral implant.

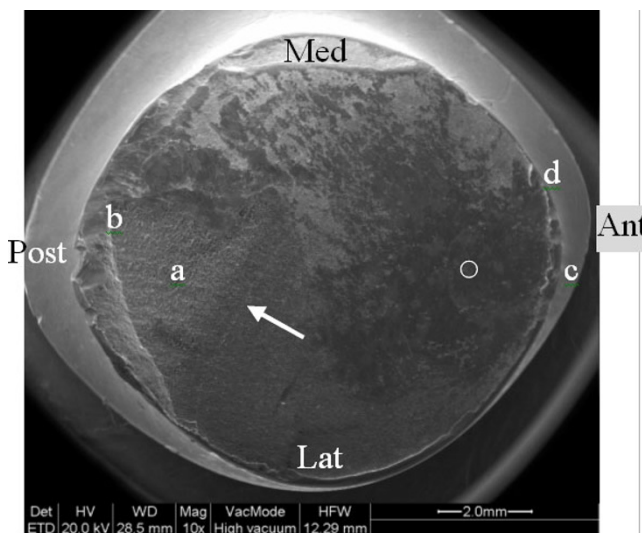
Figure 5
Fracture surface of the head-side. View of the surface fracture of the head side: the arrow indicates the beginning of the intergranular fracture. Regions a and b indicate the location of the intergranular fracture and the shear lip. Regions c and d indicate the location of the anterior laser markings (letters "E" and "D" respectively).

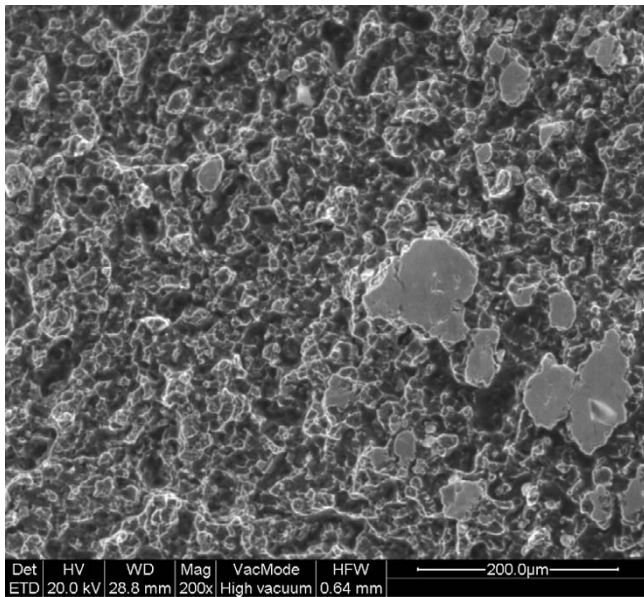
Figure 6
Intergranular fracture (region a).

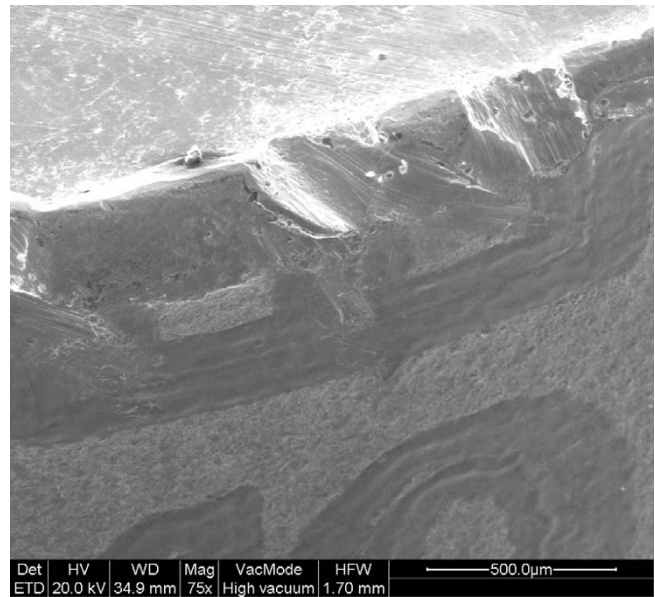
fatigue fracture, mainly because of the tool marks and of the abraded surface in this region (figures 8 and 9). No typical striations could be found near the edge of the surface. The marks shown in figure 8 (near the "O") are more probably due to attrition because there are several such marks in this region, with different orientations.

Figure 8
Edge of the fractured surface, in the vicinity of a laser marking (Letter "E", region c).

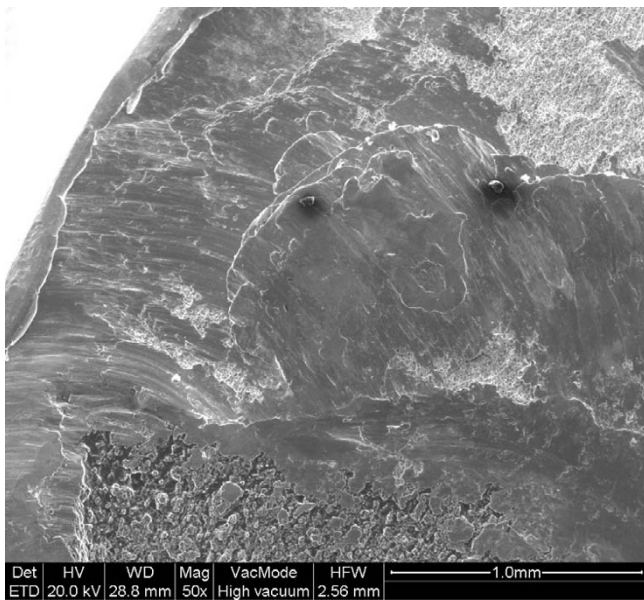
Figure 7
Shear lip (region b).

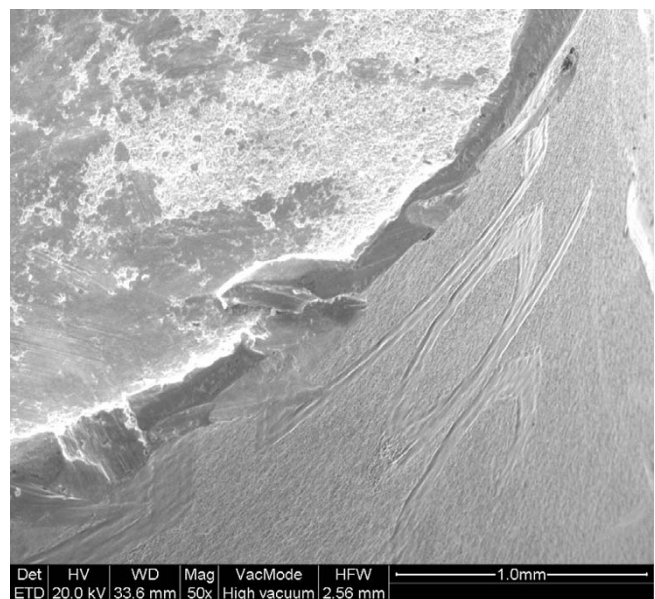
Figure 9
Edge of the fractured surface, in the vicinity of a laser marking (Letter "D", region d).
